Manhole Inspection Summary

Manhole # S29G__029MH

Insp Date: **12/2/08 1:29 PM**

Location Address: **633 e baltimore st**

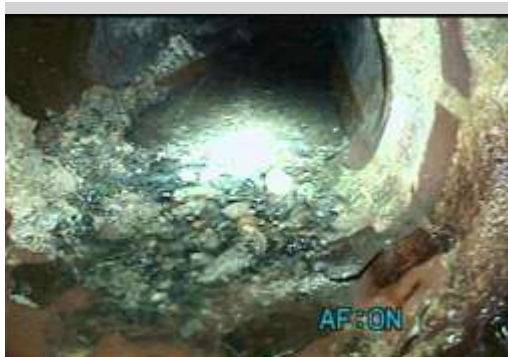
Misc Channel Debris

channel debris

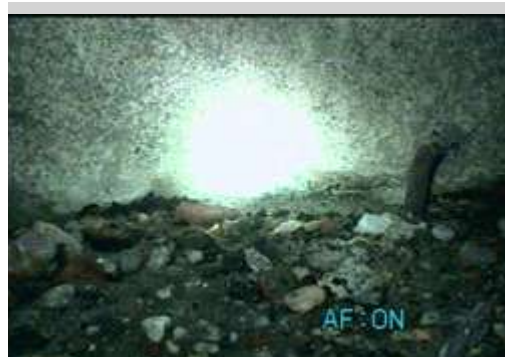
Misc Bench Debris

bench debris

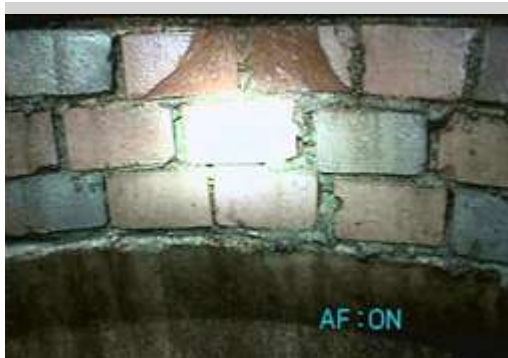
Defect 2

Condition: ☐ Sound ☒ **Cracked** ☐ Root Intrusion ☐ Loose Brick ☐ Deteriorated

frame adj cracked

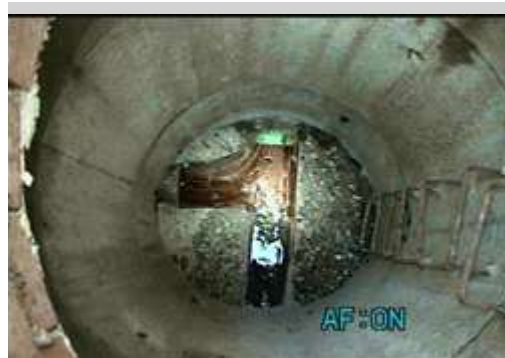
Defect 1

Count: **9** Missing: **0** ☒ **Corroded**

corroded steps

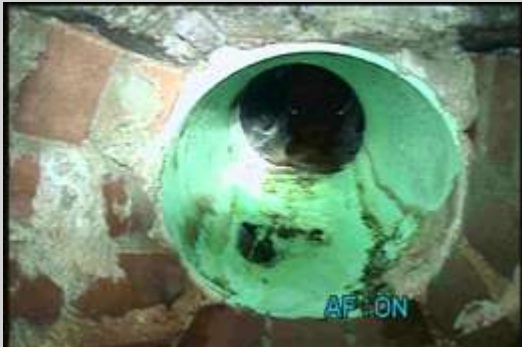
12 O'Clock Outflow

10 in. Circular Gravity Sewer
Pipe Out @ 12 O'Clock

Invert Depth: **12.33** (ft.) Flow Characteristics: **Slow**

Infiltration: **None** Pipe Seal Cond: **Unknown**

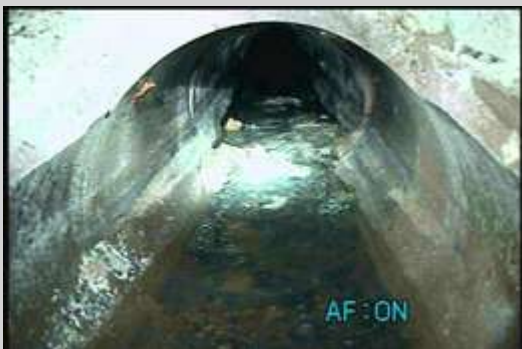
6 O'Clock Inflow

10 in. Circular Gravity Sewer
Pipe In @ 6 O'Clock

Invert Depth: **12.25** (ft.) Flow Characteristics: **Slow**

Infiltration: **None** Pipe Seal Cond: **Unknown**

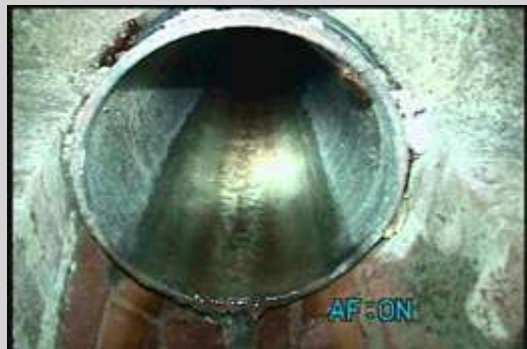
9 O'Clock Inflow

10 in. Circular Gravity Sewer
Pipe In @ 9 O'Clock

Invert Depth: 11.50 (ft.) Flow Characteristics: Slow

Infiltration: None
